Drain: OVERMAN - HARVEY Drain #: 37

Improvement/Arm: ARM | RELOCATION

Drain-Improvement: Overman - HARVEY - ARM | RELOCATION

Re: Overman Harvey Drain

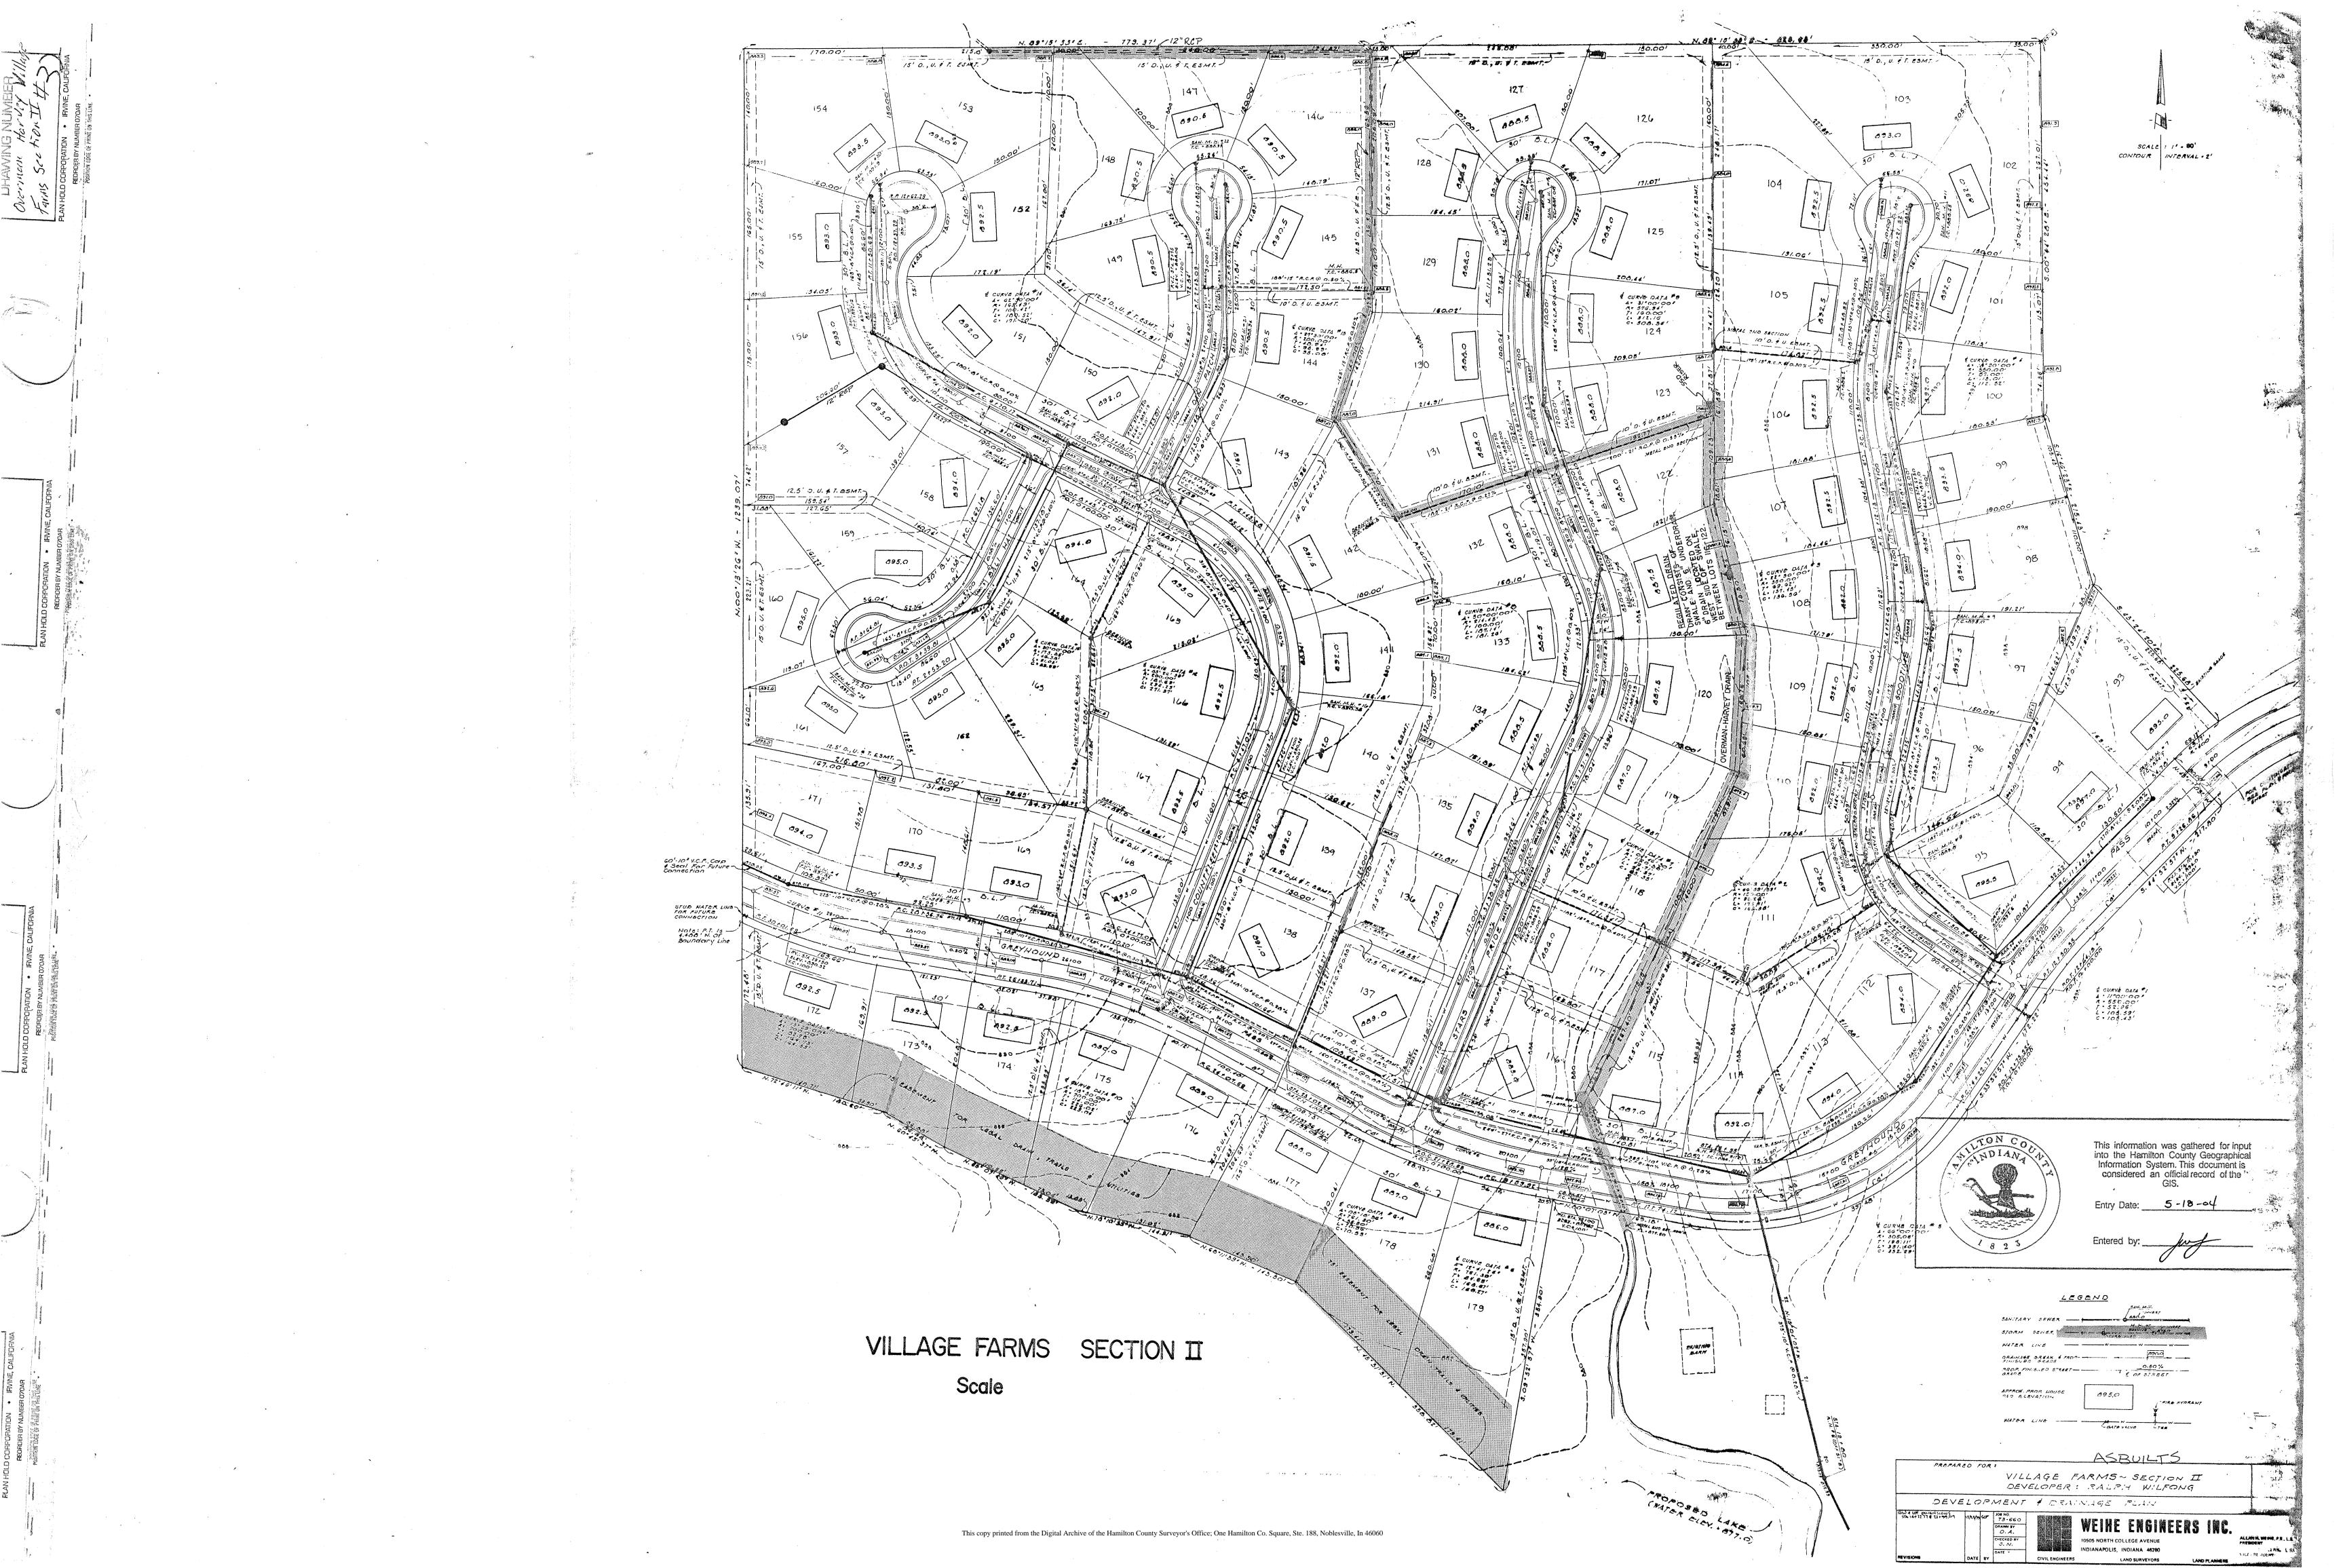
I have marked in red the portion of this storm sewer which is close to the location of what was the Arm of the Overman Ditch.

I believe that the storm sewer which is described below should be considered as the relocated Arm 1 of the Overman Drain. This Arm begins in a catch basin approximately 80 feet west of the northeast corner of lot 153 of Village Farms Section 2, thence run east 444 feet in a 12" RCP to a catch basin in the north east corner of lot 146 of said subdivision, thence S 00° 44' E in a 12" RCP 300 feet to a catch basin, thence S 18° 23' W in a 15" RCP 165 feet to a catch basin, thence 140 feet S 32° 15' E in a 15" RCP to a catch basin. The storm sewer then turns N 71° 02' E and runs 185 feet in a 21" RCP to a curb inlet then 25' in a 21" RCP to another curb inlet, thence 200' in a 21" RCP to a outlet empting into a surface mater swale/retention area.

This system for the most part is in good working order. However there does exist two problems which need to be taken care of. One of these occurs at the outlet of the 36" RCP. At this point a load of riprap should be placed below the outlet in the channel to prevent erosin.

The other is more serious. There are several areas along the swale at which standing water occurs. To try to solve this problem the developer put in a 6" SSD along the swale which empties into the 36" RCP. This did not solve the problem. In my opinion, because of what I've seen, the tile was improperly installed. I believe this tile should be investigated and if necessary either relaid or replaced with another. Doing this along with putting in french drains should relieve this problem.
