**Drain:** W. H. TETER **Drain #:** 63  
**Improvement/Arm:** 1980 Extension  
**Operator:** J. LIVINGSTON **Date:** 7-2-04  
**Drain Classification:** Urban/Rural **Year Installed:** 1980

**GIS Drain Input Checklist**

RE: N. H. Teter Drain

Attached is a report and design for reconstruction of the outlet of the N. H. Teter Drain. The plans call for a rock chute at the tile outlets and dredging 500ft of open ditch.

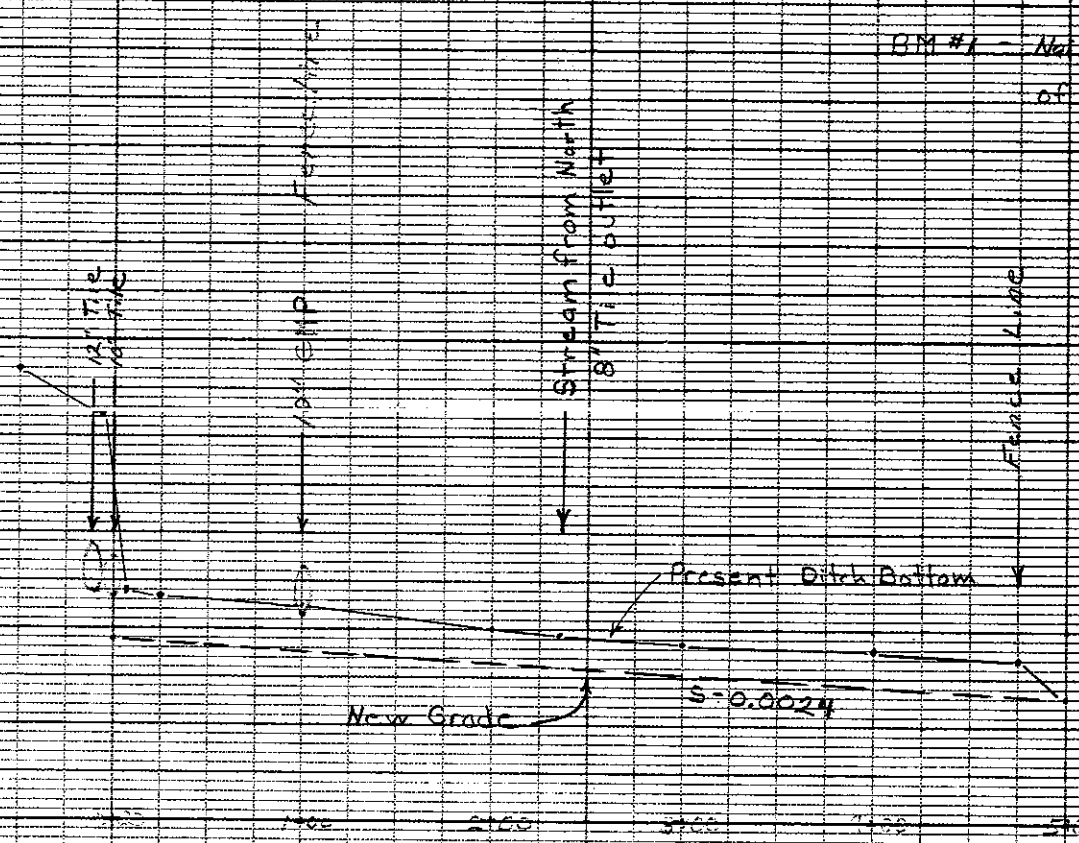
**DESIGN DETAILS**

LINE	STATIONS	DRAIN AREA ACRES	DITCH DIMENSIONS				TILE SIZE INCHES	GRADE %	DRAIN COEF OR CURVE	VELO-CITY Ft/Sec.	CAPACITY	
			DEPTH FEET	TOP FEET	BOTTOM FEET	SIDE SLOPE					REQ'D	AVAIL.
											c.f.s.	c.f.s.
Main	0+00-5+00	2.19	3		4	2:1	-	0.24	B	3.1	36	36

Bench Mark Description:  
TBM #1 - Nail in Northside of large tree, 75' South of windmill.

- Materials:**
1. Rockchute - 100 Ton of stone
  2. CMP's 1-15"  
1-12"
  3. Dredge 500' of channel
  4. Relocate 50' of 12" Tile
