**Drain:** Wilson - HAGLE      **Drain #:** 175  
**Improvement/Arm:** WILLIAM WILSON - MAIN ST REPAIR  
**Operator:** J. LIVINGSTON      **Date:** 9-9-04  
**Drain Classification:** Urban/Rural      **Year Installed:** 1990

Drain-Improvement: WILSON-NAGLE: WILLIAM WILSON - MAIN ST REPAIR

This letter is in regard to the work that has been done on the Wilson Ditch crossing on East Main Street in Arcadia.

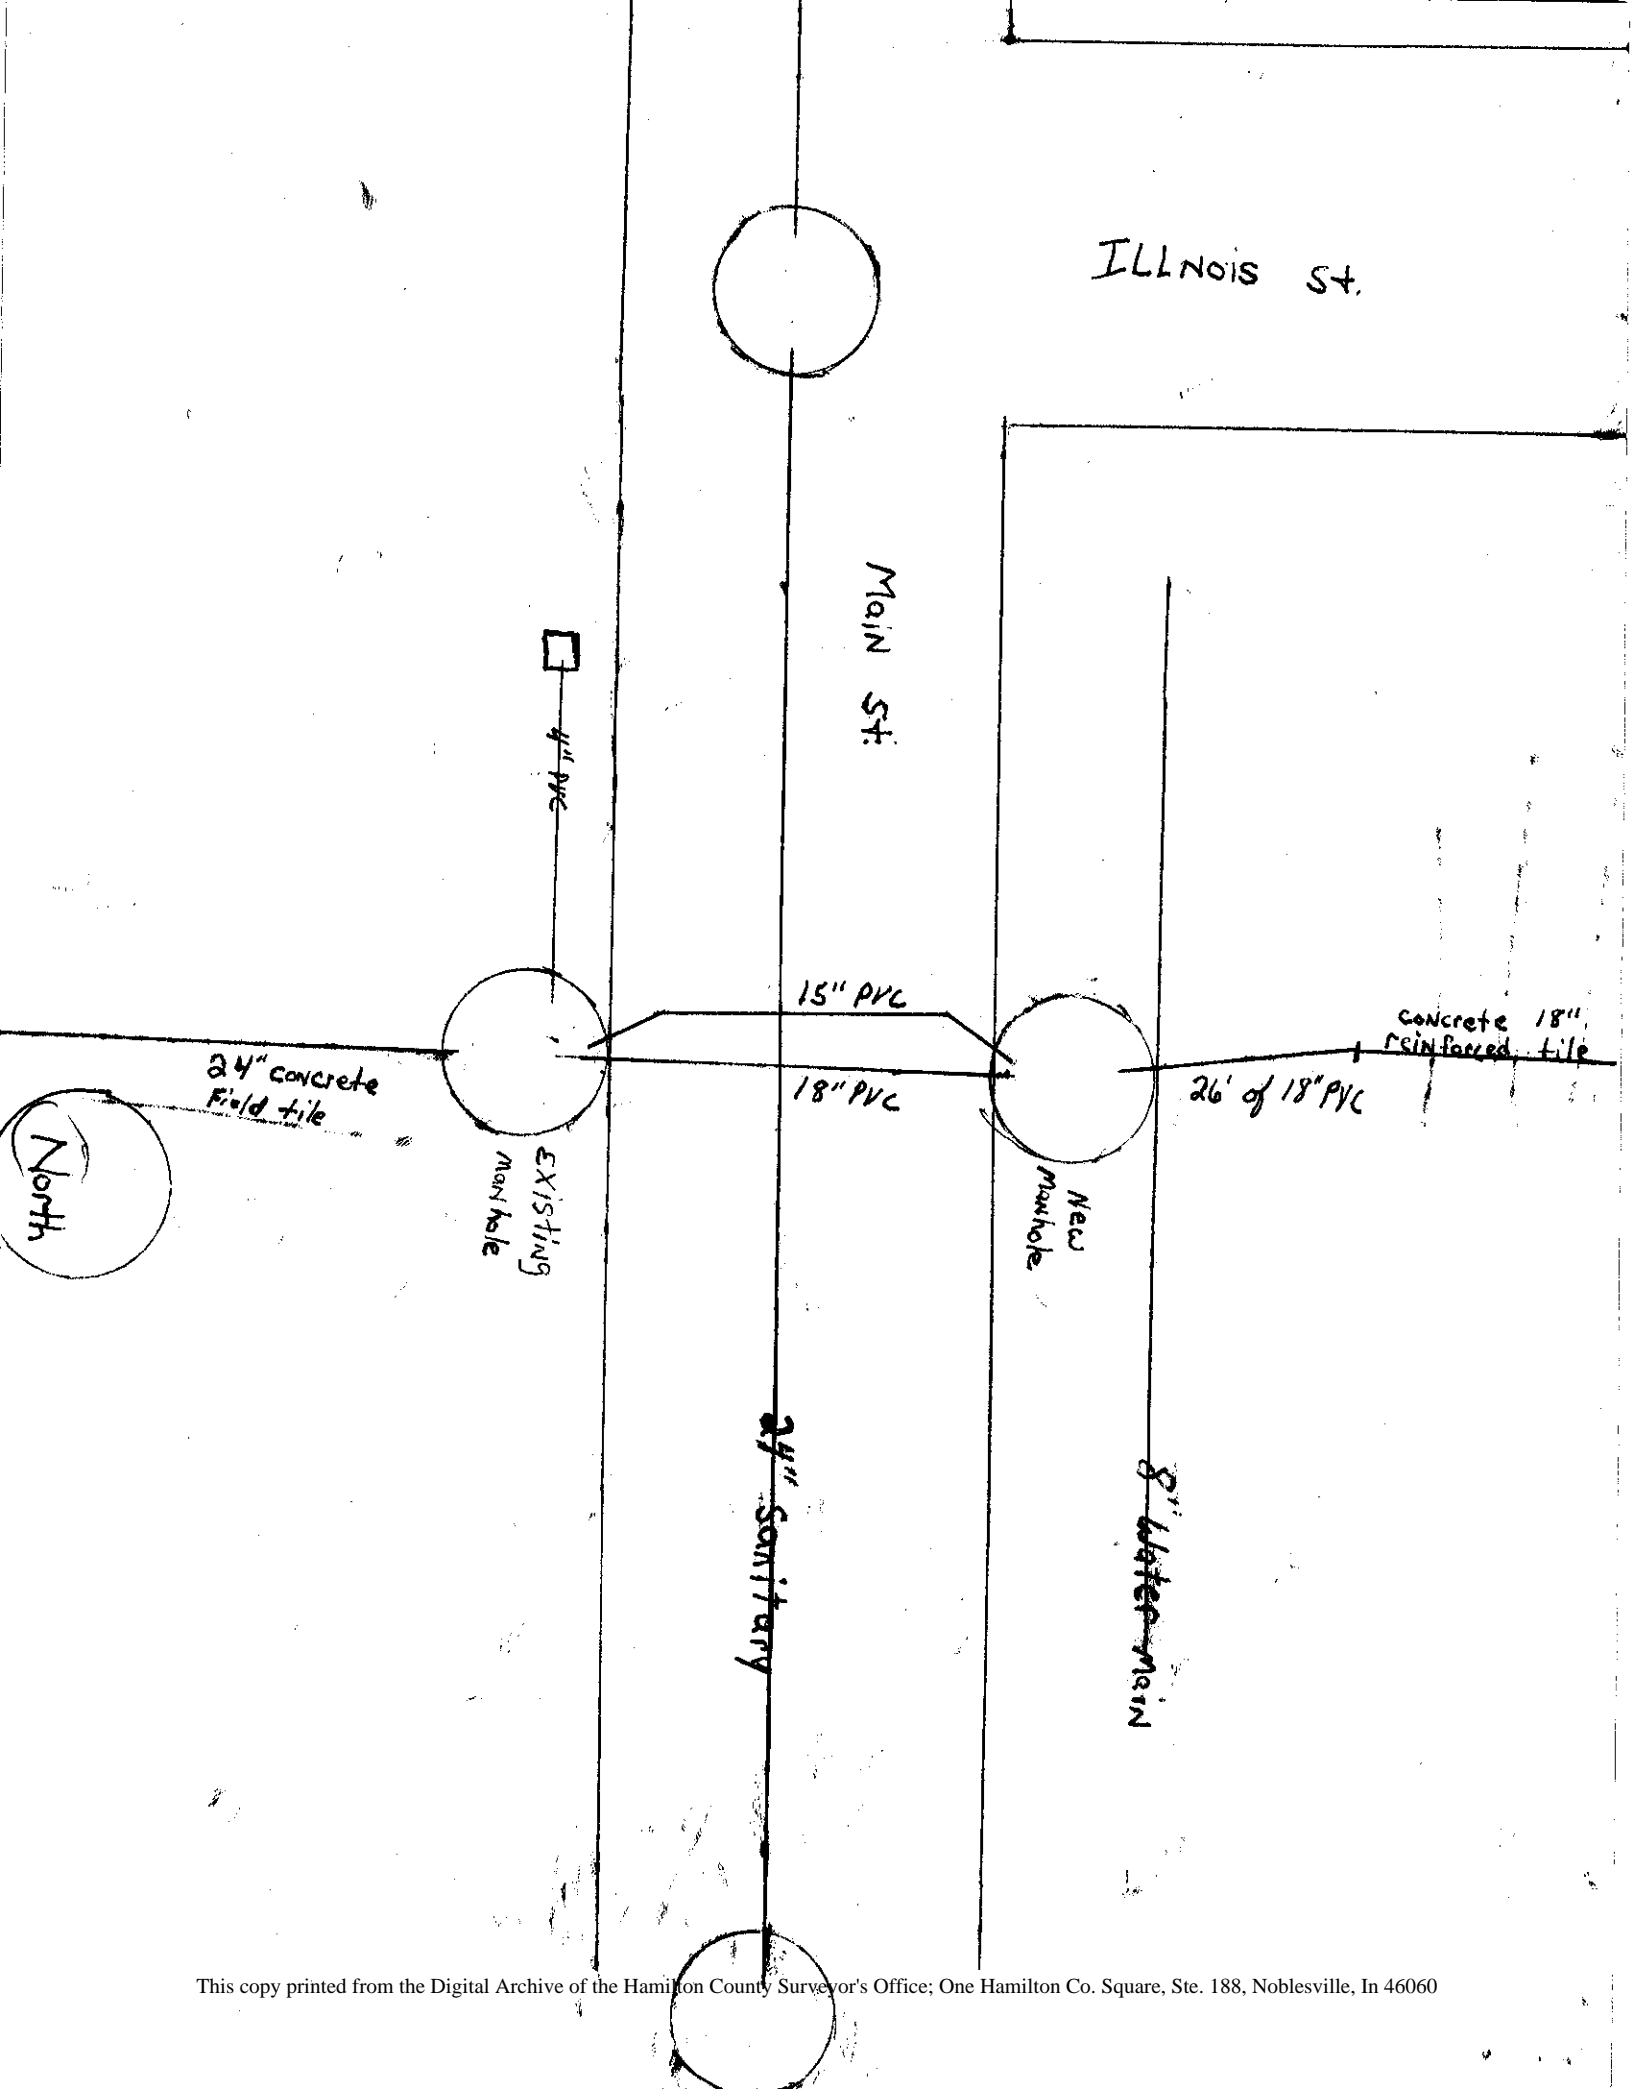
A sink hole developed in the middle of Main Street. After it was uncovered, we found that a section of our sanitary sewerline had broken down and we were getting infiltration from Wilson Ditch causing the sand to wash out, creating a sink hole.

After repairing the sanitary sewer line with 24" PVC, we replaced the section of Wilson Ditch crossing Main Street with 18" PVC, leaving the 15" PVC by-pass that was put in a few years back. Then we set a new manhole on the south side of Main Street directly over the Ditch. The line going out of the manhole was connected to the existing 18" reinforced concrete tile that goes along the east side of Leonard Apartments.

I am including a sketch to show the exact repair done on the Ditch. If you have any questions, please feel free to call me at 984-3512.
