## **GIS Drain Input Checklist**

RE: Harvey Gwinn Drain

The Harvey Gwinn Drain is scheduled for a maintenance hearing February 26, 1996. As you are aware the upper end of the open channel was reconstructed three years ago. The landowners who financed the project, are now arguing that they should have a reduced maintenance assessment. I agreed to survey the portion that was reconstructed and give my opinion to it's condition.

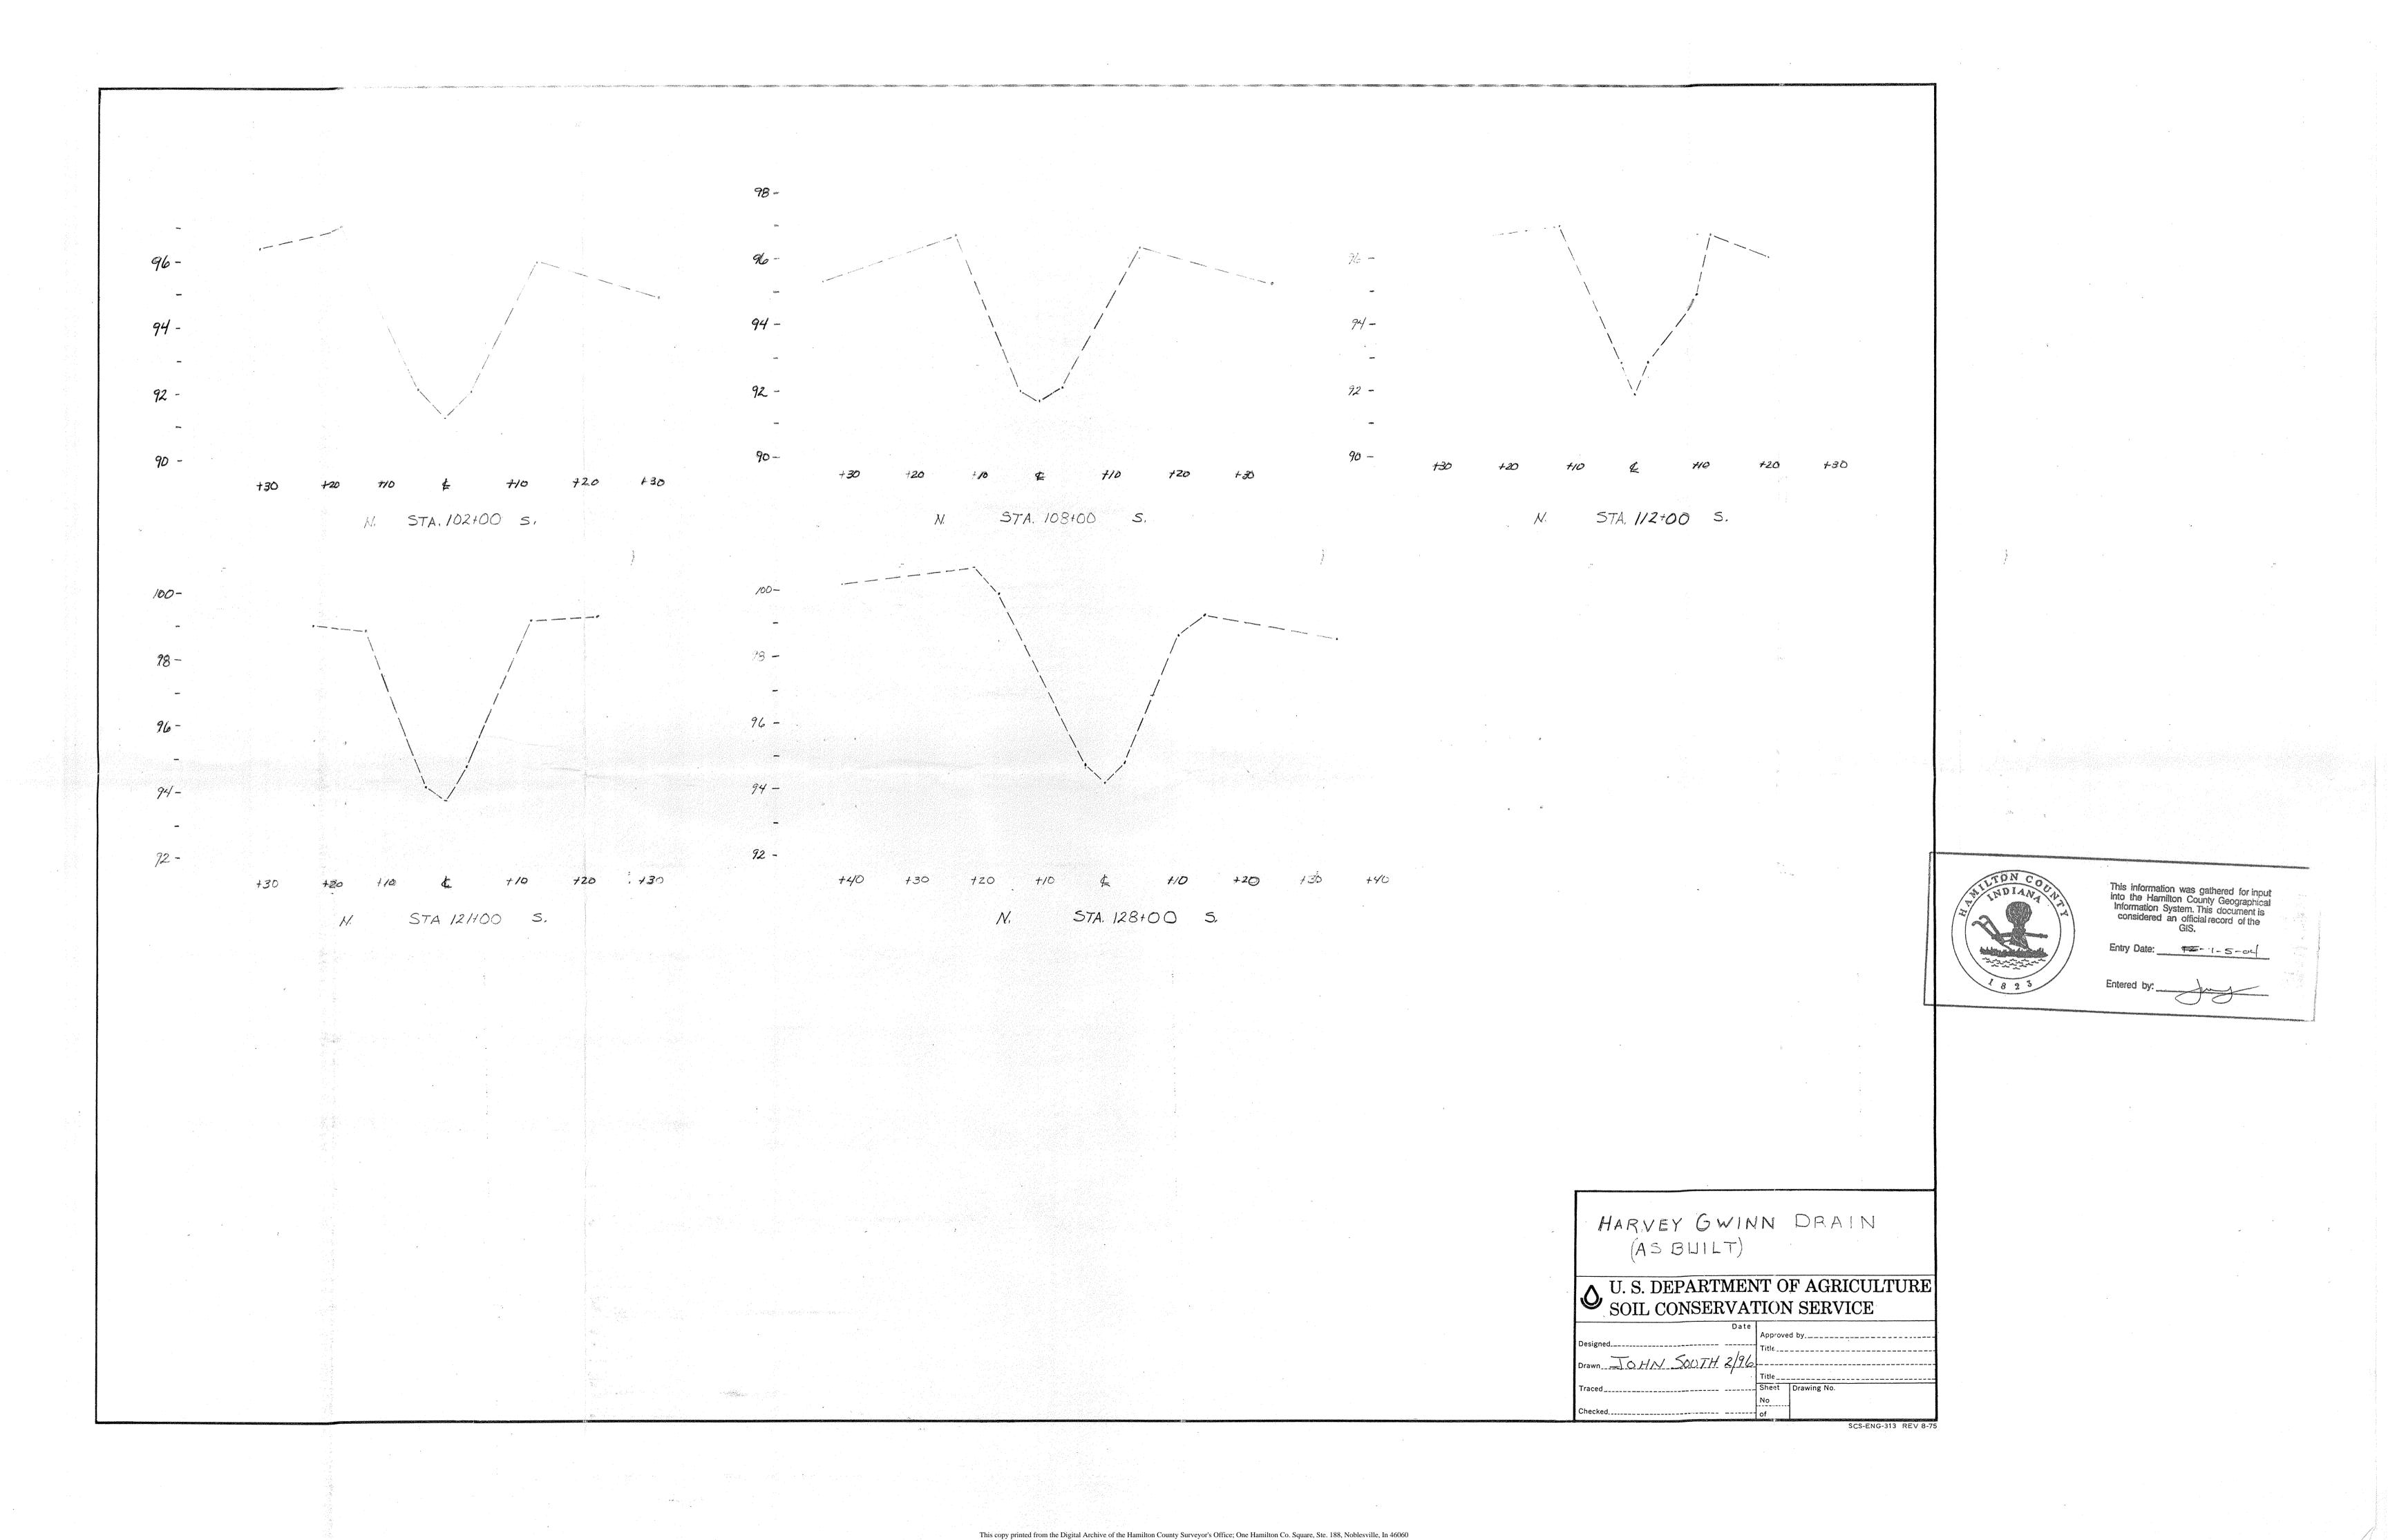
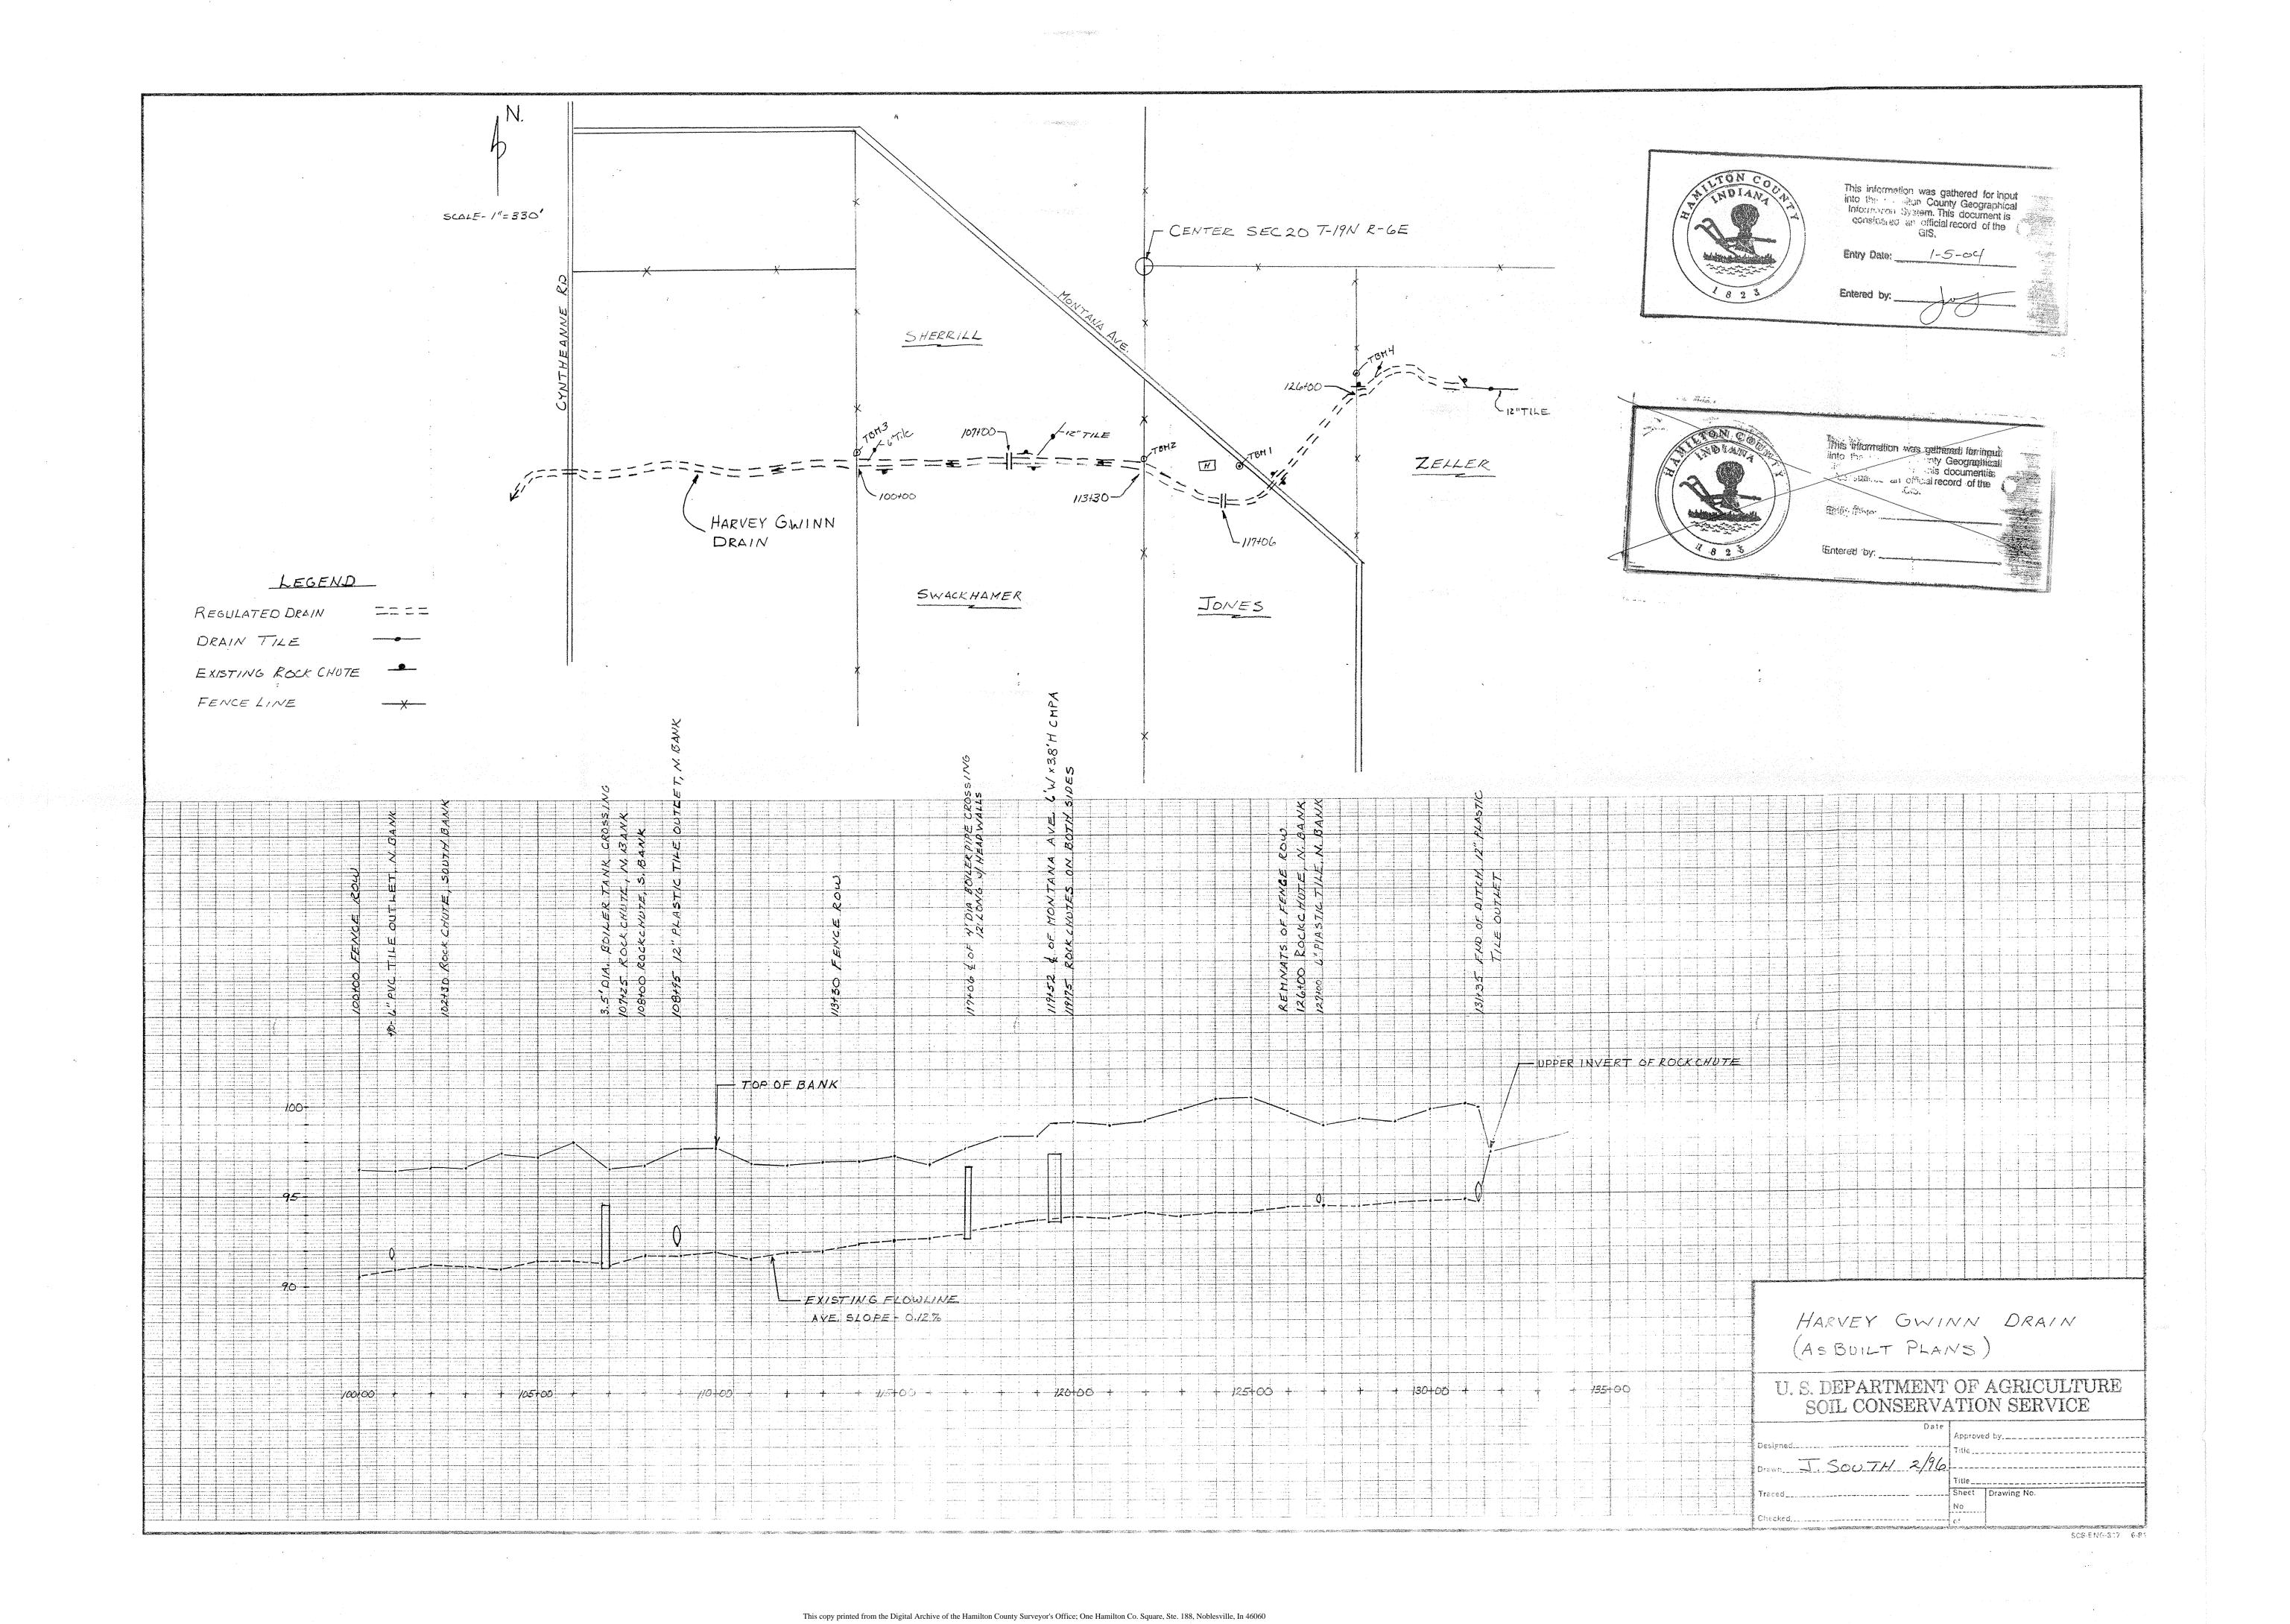
The profile and cross sections show the channel was excavated on grade with a 0.12% slope. Several tile outlets could be upgraded to metal with animal guards. If the reconstruction was a County project, the culvert at Montana Avenue may have been lowered to improve the tile outlet at the head of the ditch. Enclosed is a copy of the profile and cross-sections of the recent survey.

In general the channel is in excellent condition and should require very little maintenance for the next 10-15 years. Seeding the ditch banks and installing an animal guard on the county tile are the only practices that need to be completed at this time.
