**Drain:** SCHNEIDER ? PERCE      **Drain #:** 100  
**Improvement/Arm:** JACOB SCHNEIDER EXTENSION  
**Operator:** J. L. LIVINGSTON      **Date:** 6-4-1981  
**Drain Classification:** Urban/Rural      **Year Installed:** 1981

Drain-Improvement: SCHWEIDER & PIERCE - JACOB SCHWEIDER EXT.

Re: Schneider-Pierce Drain

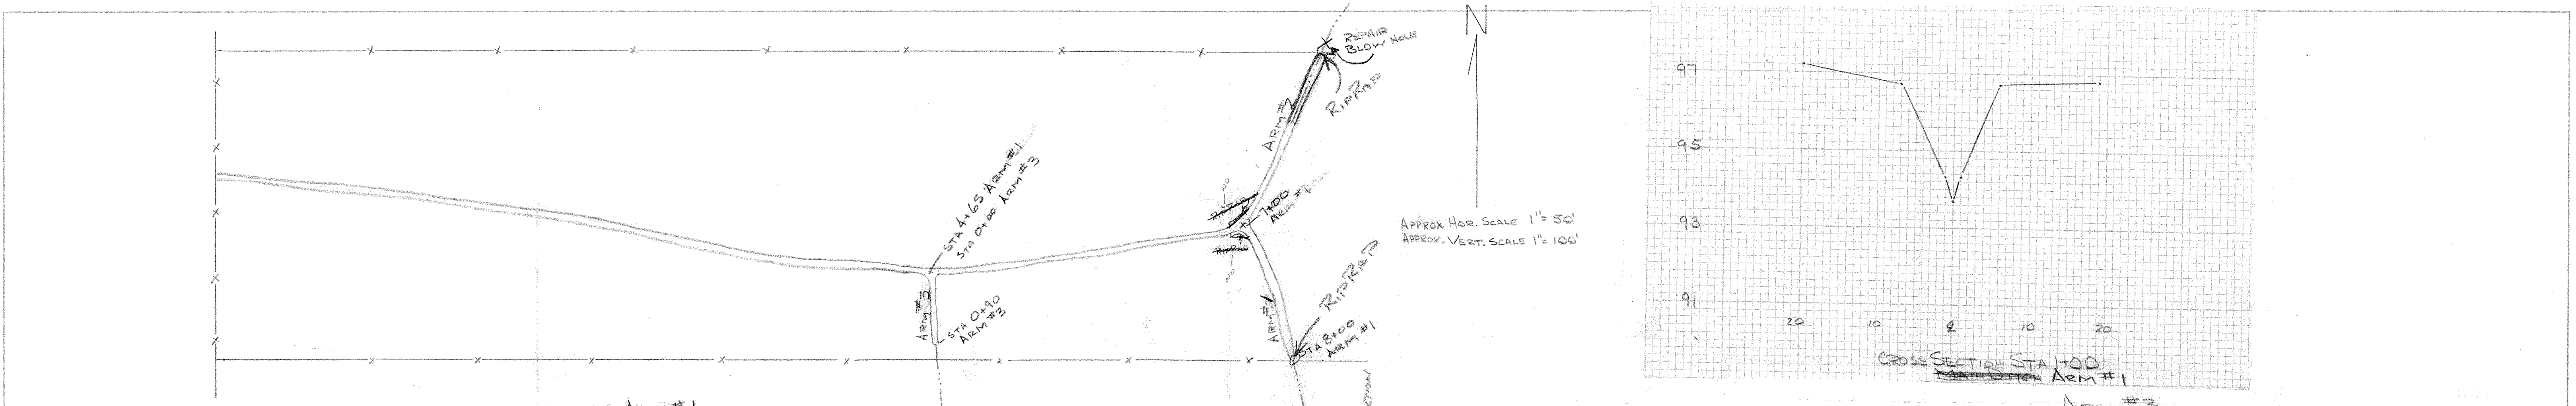
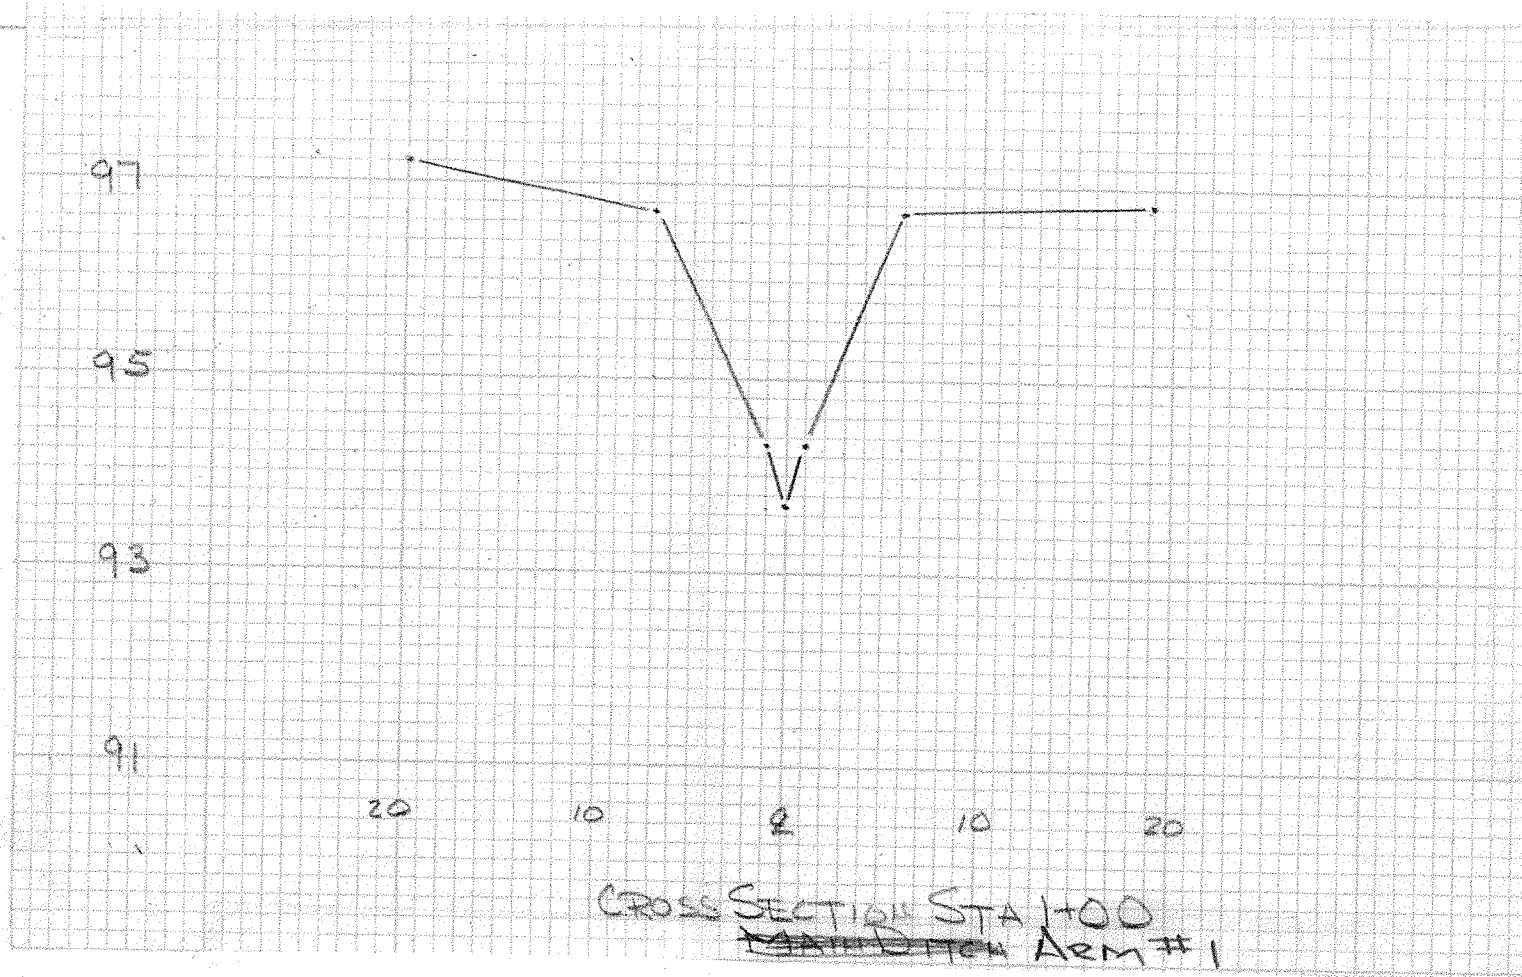
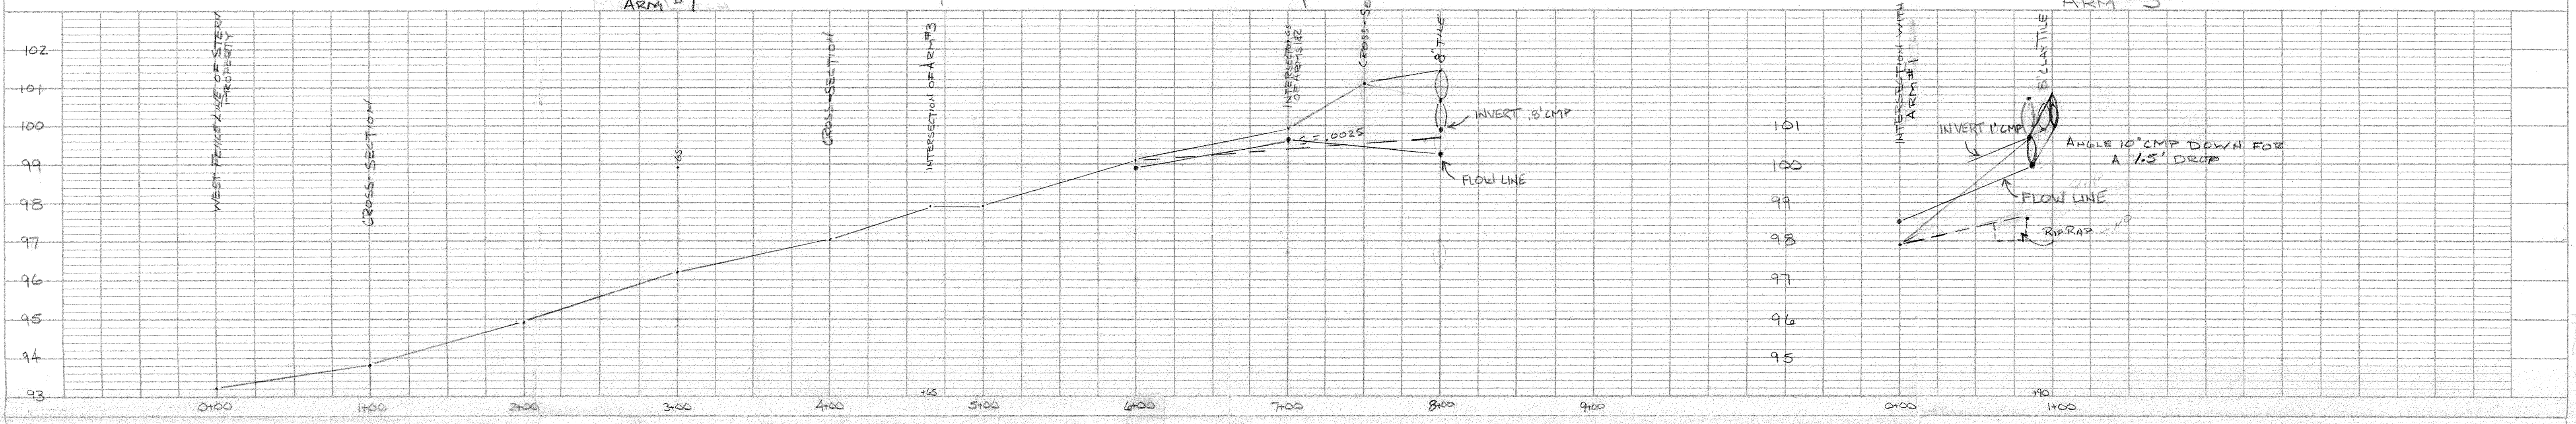
STERN ARMS TO JACOB SCHNEIDER DRAIN  
 BM #1 - ELEV 100.00 - PK NAIL IN FENCE POST 100' NORTH STA 0+50 OF ARM #1  
 BM #2 - ELEV 105.8 - PK NAIL IN TREE EAST STA 1+50 OF ARM #2

The location of this extension is shown in red on the attached map and is described as Arms 1, 2 and 3 of the Jacob Schneider Drain. These descriptions are as follows:

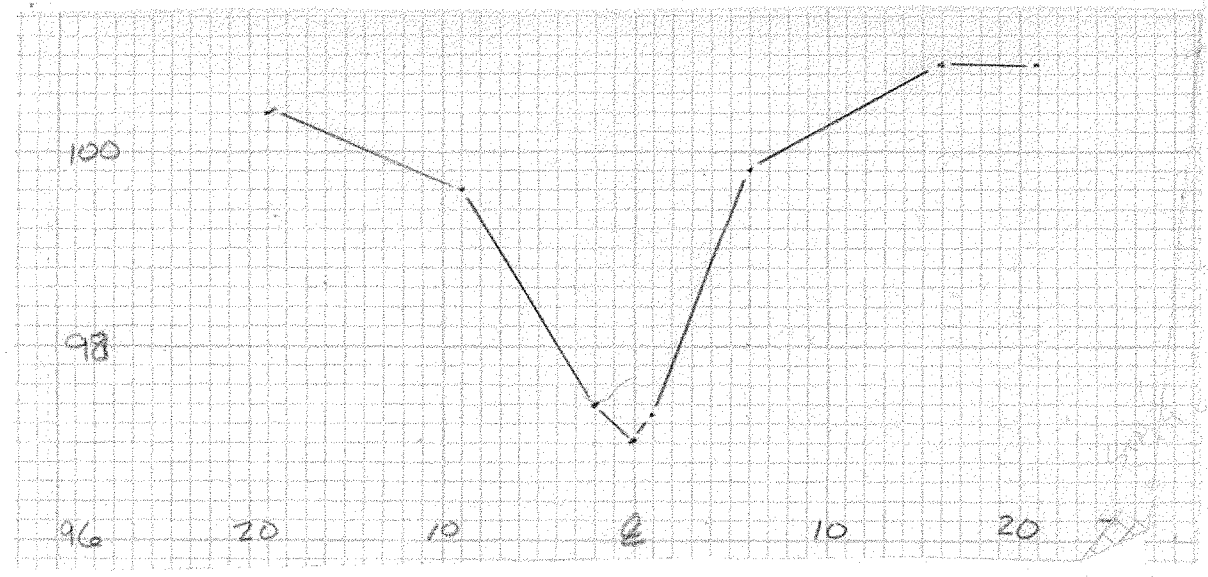
CROSS-SECTION STA 4+00 ARM #1 DITCH

NOTE: NEW OPEN DITCH ON ARMS 1 AND 2 TO HAVE 4 FOOT BOTTOM WIDTHS AND 2:1 SIDE SLOPES. ARM 3 TO HAVE 4 FOOT BOTTOM WIDTH WITH SIDE SLOPES TO MATCH EXISTING.
